16 Henry Street, Nirimba QLD, Australia

Pre-Purchase Standard Property & Timber Pest Report

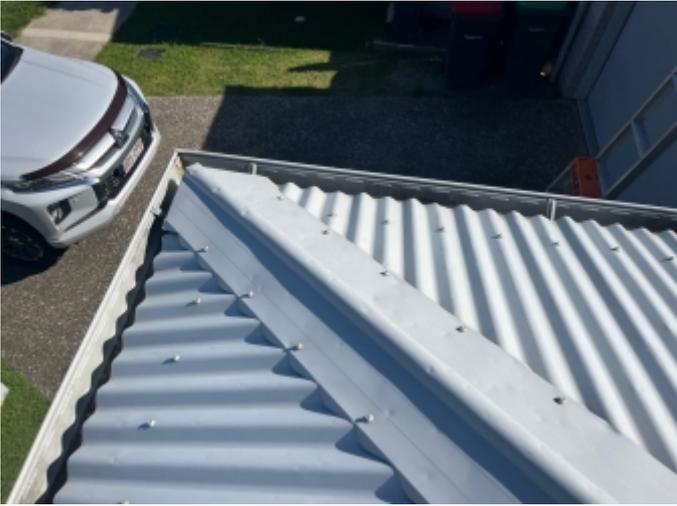
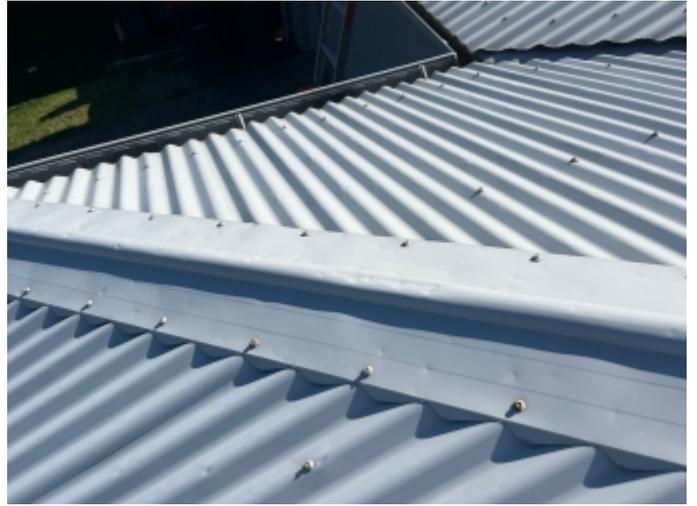
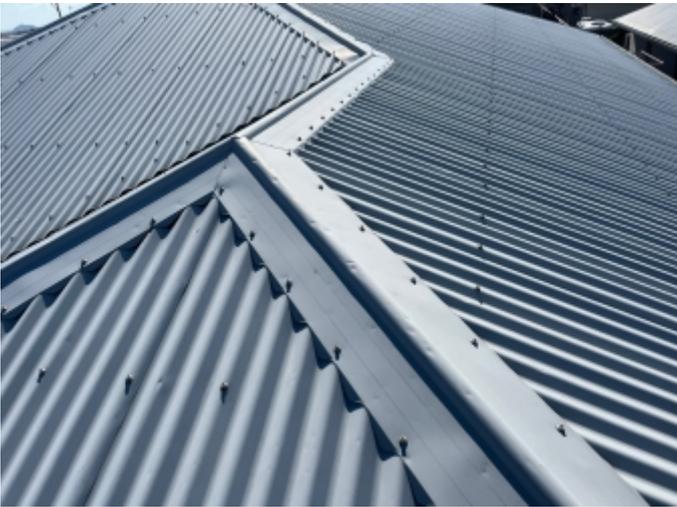
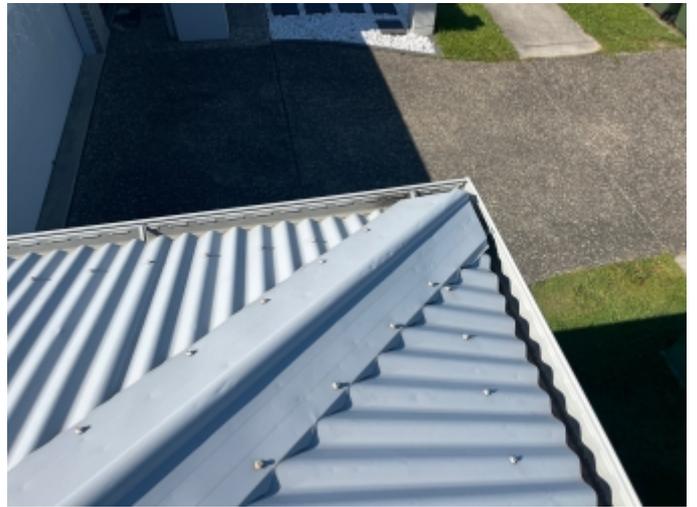
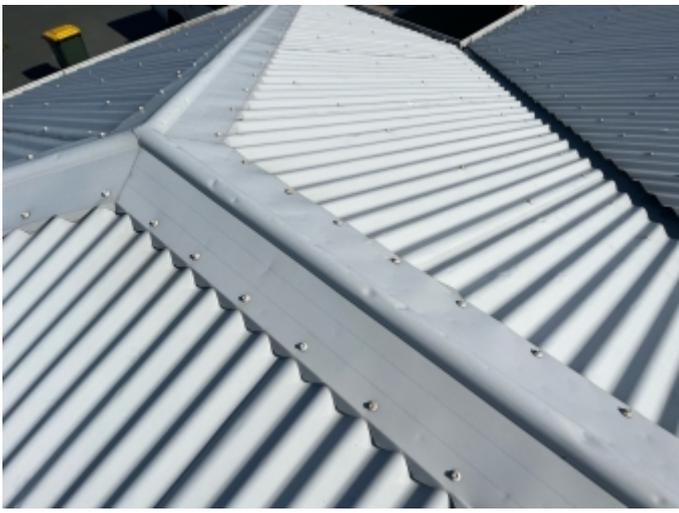
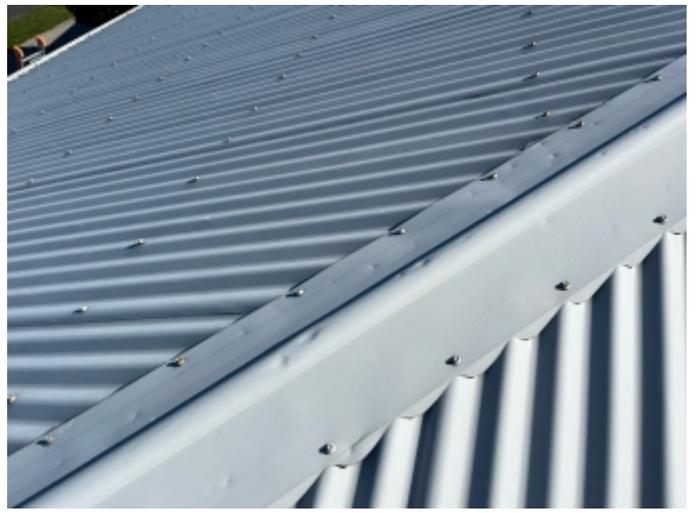
Roof Exterior Defects

Details of Major Defect	Significant denting to throughout roof. Appears hail damage. Consult hail specialist regarding assessment and check with owner regarding if any previous hail claims made.
Photo(s) of Defect

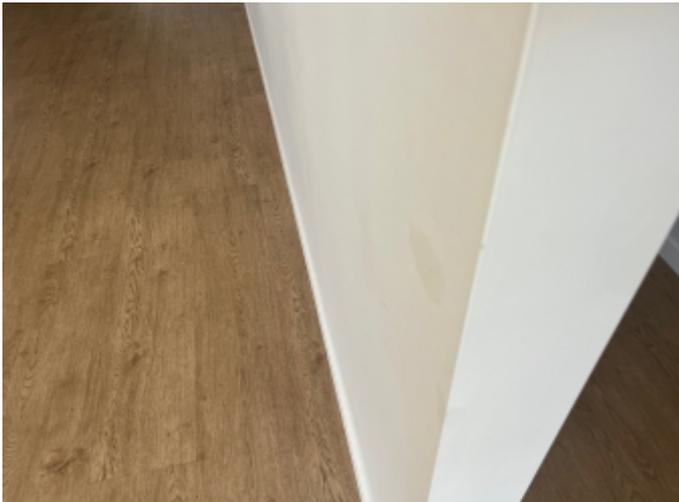
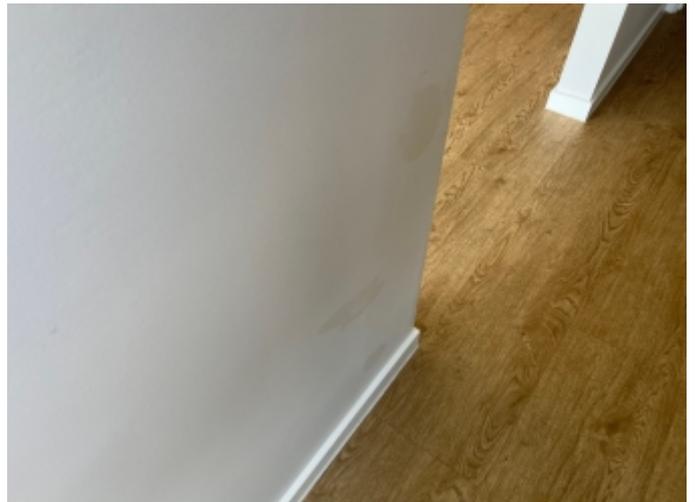
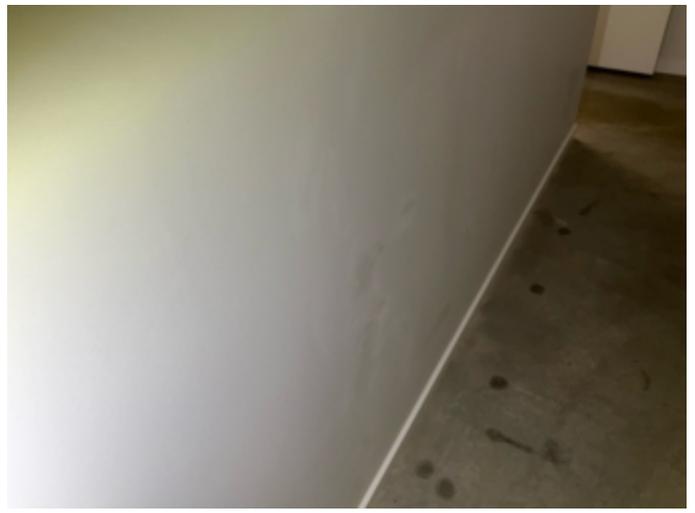
Internal Walls	Sub-standard painted/finished parts of the building
Photo

Showing example of the substandard finished/painted parts of the building

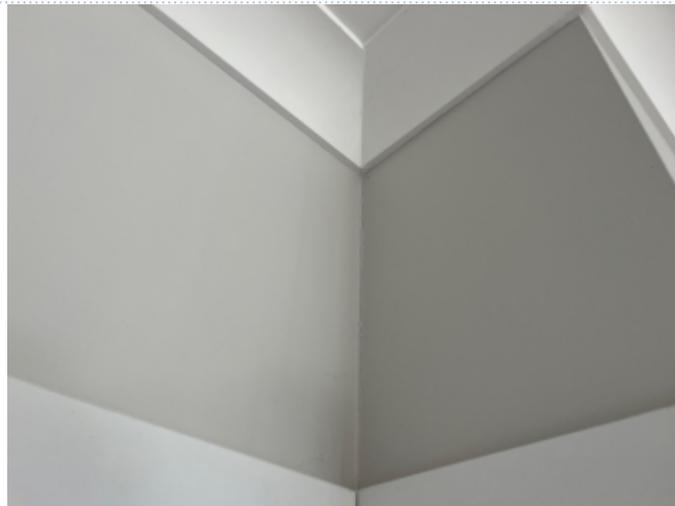
Identified kitchen

Movement cracks to areas of the walls. These cracks may be defined as minor cracks as per the relevant standards. Recommend engaging a plasterer to rectify to reduce the risk of further deterioration. If further movement is noticed, recommend engaging a builder to further investigate to reduce the risk of further deterioration.

Showing example of the cracking to the walls

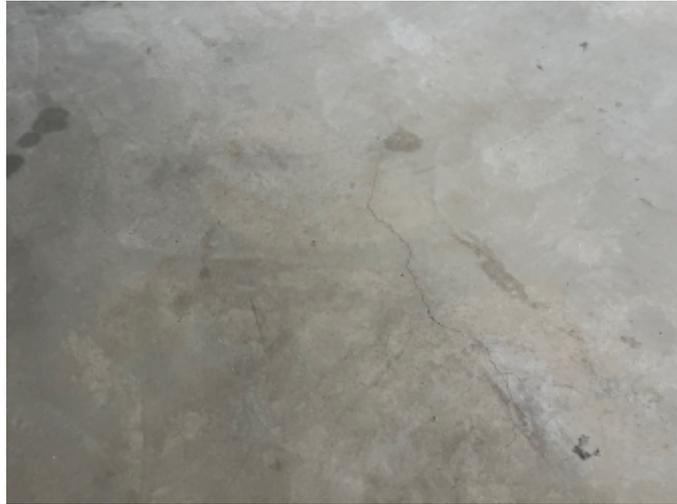
Cracking to parts of the garage slab concrete. Recommend monitoring these areas and if required engage a structural engineer to investigate and advise of any rectification works.

Showing example of the cracking

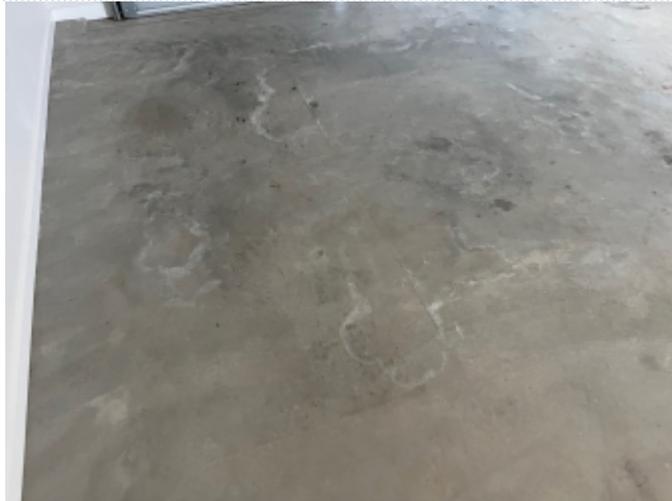
It appears there may be water staining to areas of the floors. No signs of moisture at the time of the inspection. Recommend engaging a builder to undertake further investigations to find out the cause and remedial works required.

Showing example of the stains to the floors

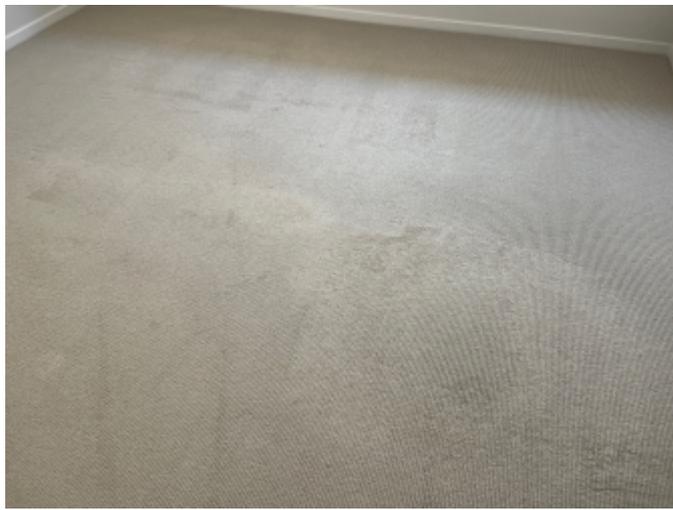
Considerable deterioration to carpet in 3rd bedroom. Consult a specialist to assess.

Showing floor covering

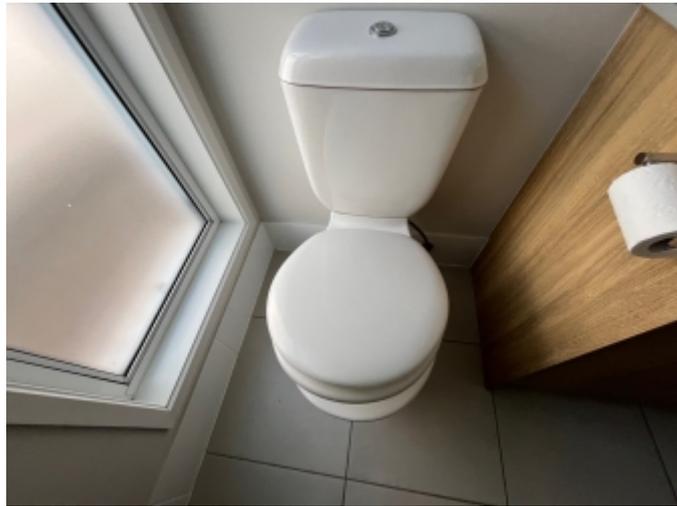
Loose toilet seat fixings. Repair required.

Showing example of the bathroom accessories

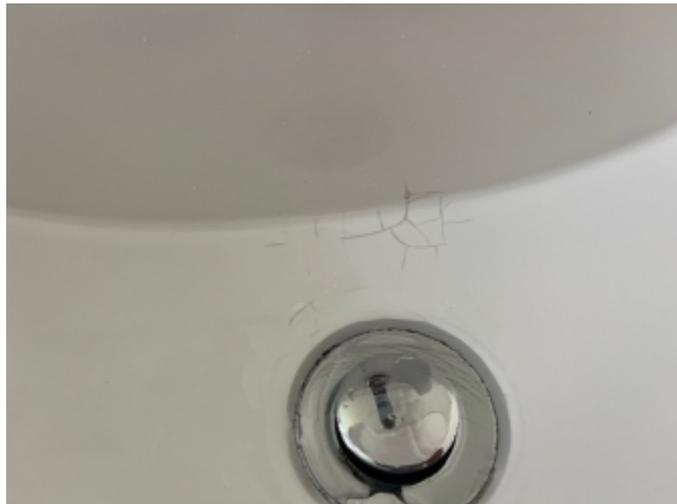
Minor cracking to ensuite basin appears to coating. Recommend monitor.

Showing example of the bathroom accessories

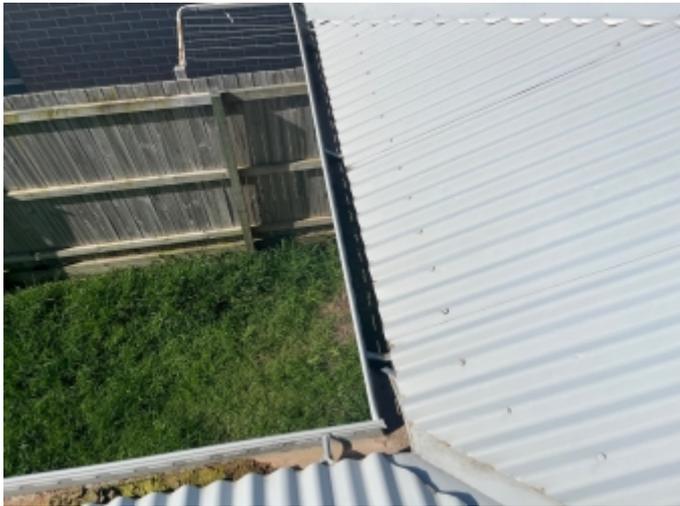
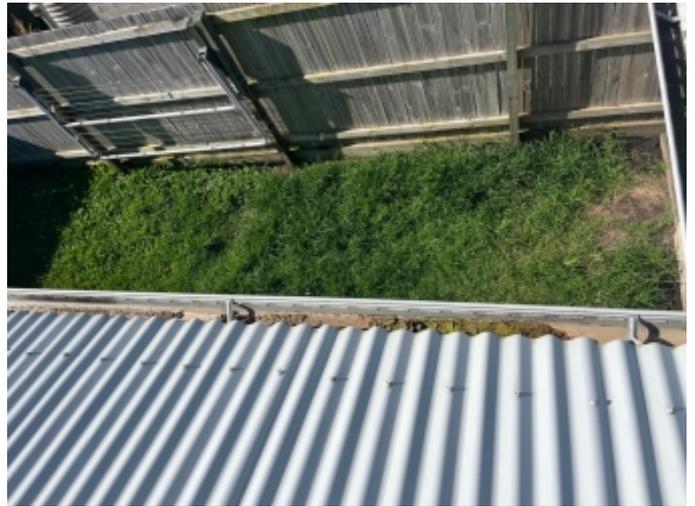
Insufficient fall to gutter/s, holding small amounts of water. Recommend a plumber to rectify to reduce the risk of rust and further deterioration of the building.

Showing example of the gutters

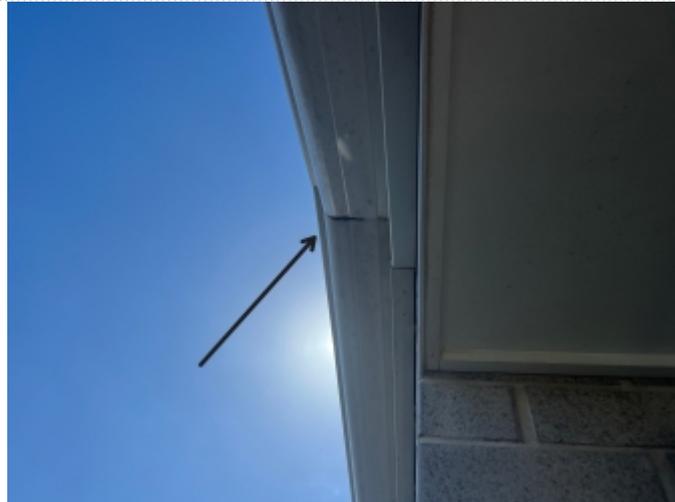
Minor leak stain to join left side. Repair as required.

Showing example of the gutters

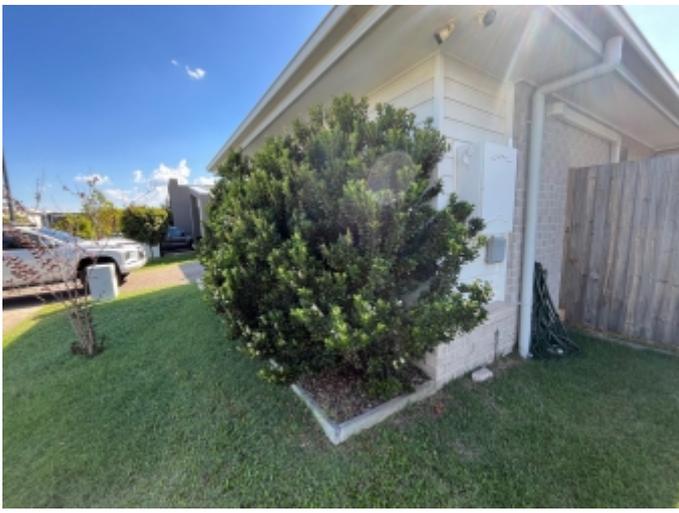
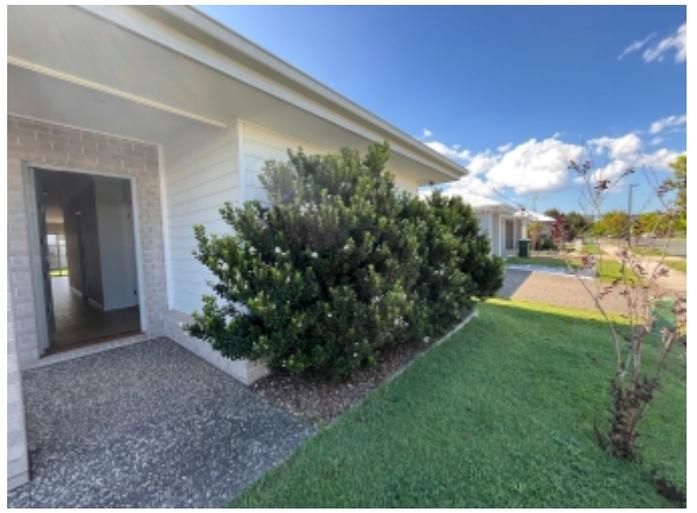
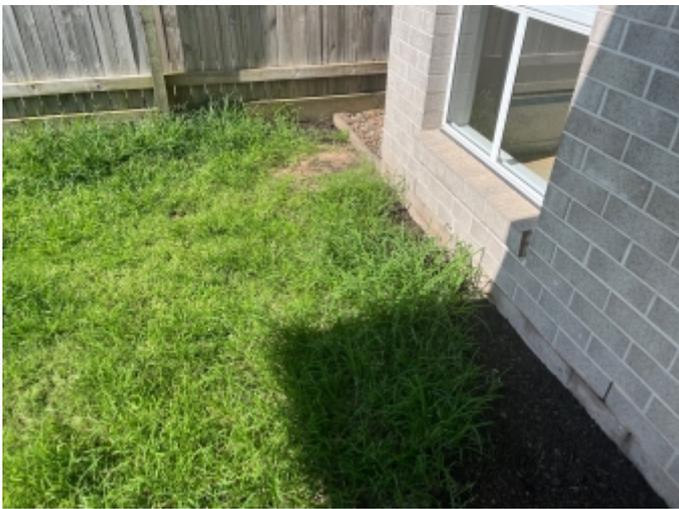
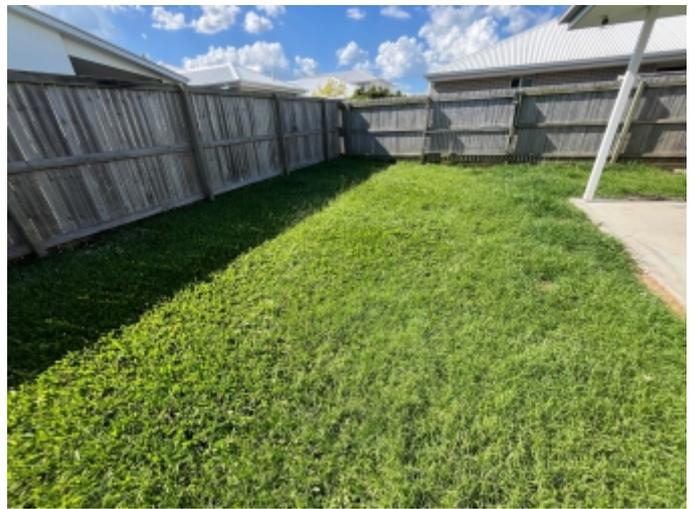
Poor surface drainage to some areas. Recommend a plumber/landscaper to rectify to prevent water ponding around the building to reduce the risk of footing movement and other moisture related issues.

Unable to determine adequacy of drainage rear yard. Recommend clear drain covered by grass and assess in rain event. Recommend remove garden abutting.

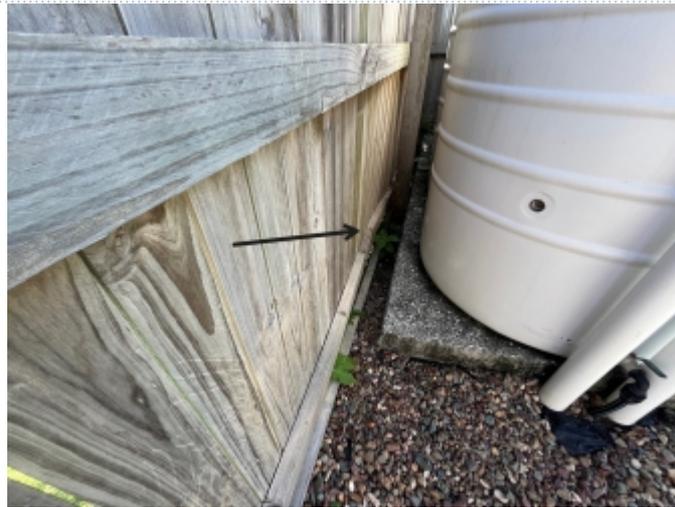
Minor distortion fence rail rear left

Showing example of the leaning/damaged fences

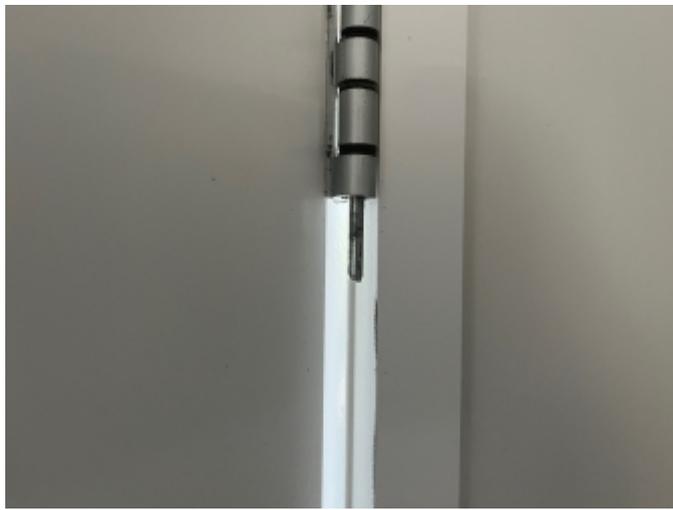
Slightly distorted entry door hinge pin. Recommend repair.

Showing example of the minor damage to parts

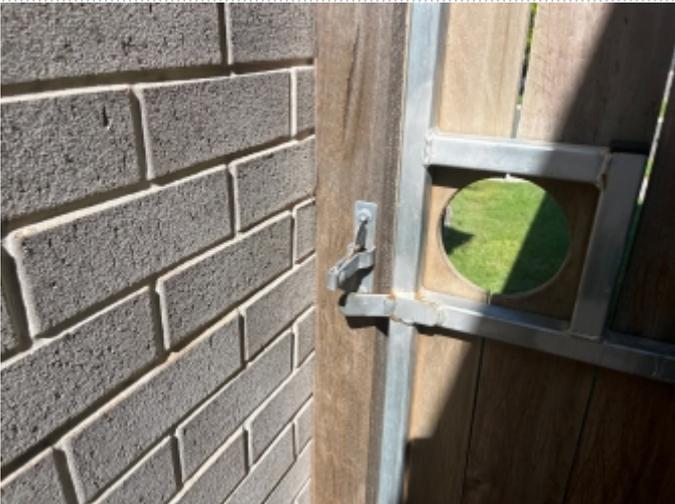
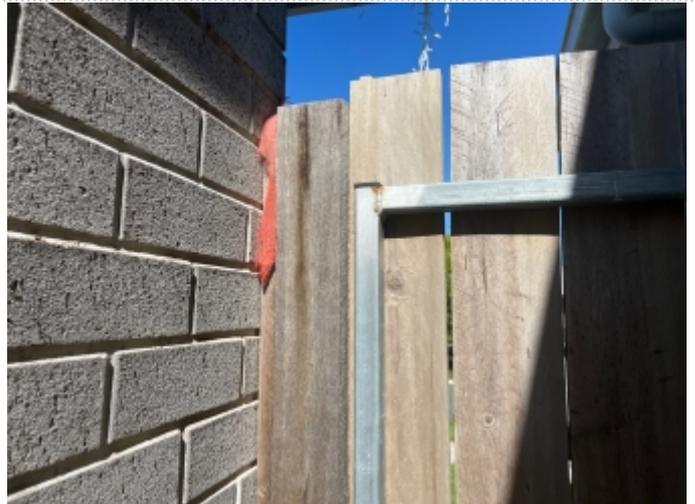
Binding and damage to gate latch right side.

Showing example of the minor damage to parts

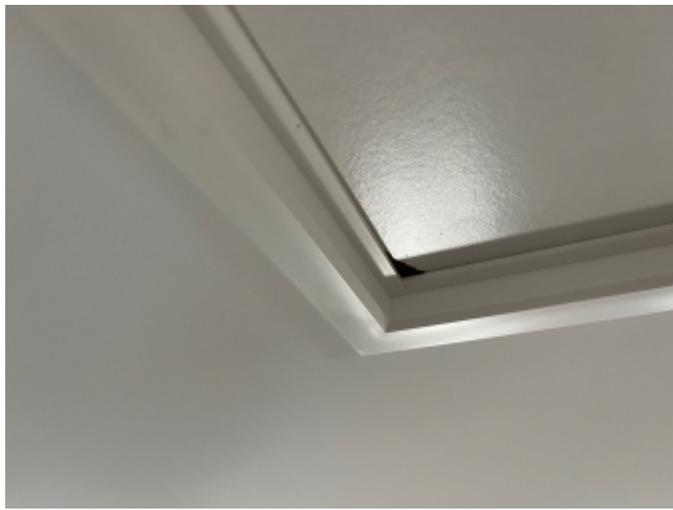
Manhole cover corner

Showing example of the minor damage to parts

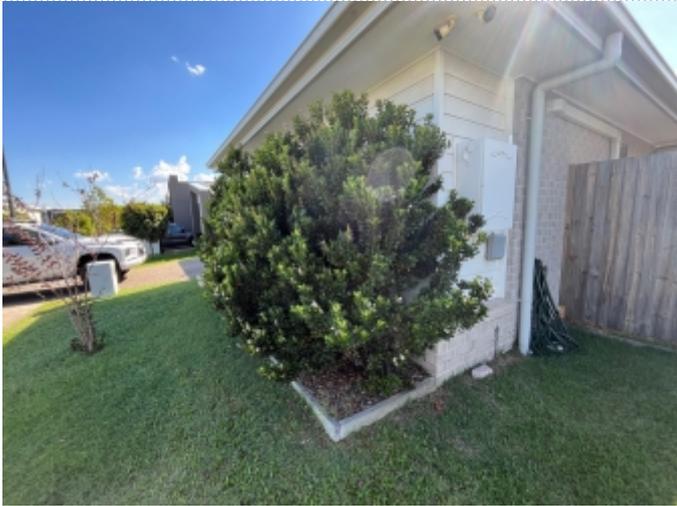
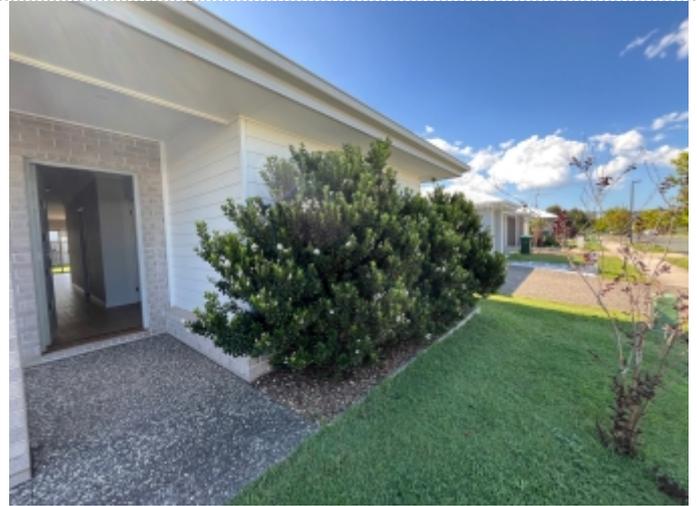
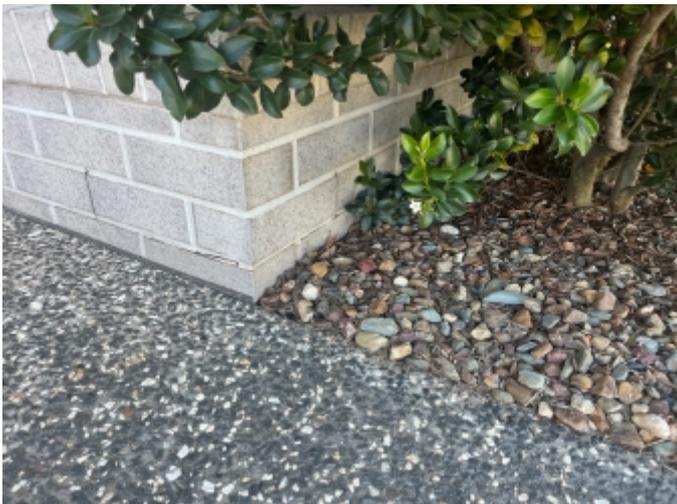
Poor surface drainage. Recommend a plumber to rectify

Showing example of the poor surface drainage areas

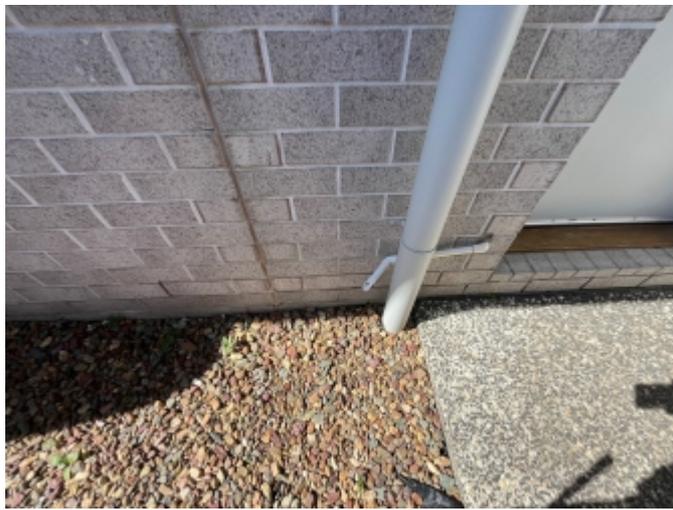
AC unit overflow/s. Recommend diverting away from the building or to a suitable drain.

Showing example of the overflows

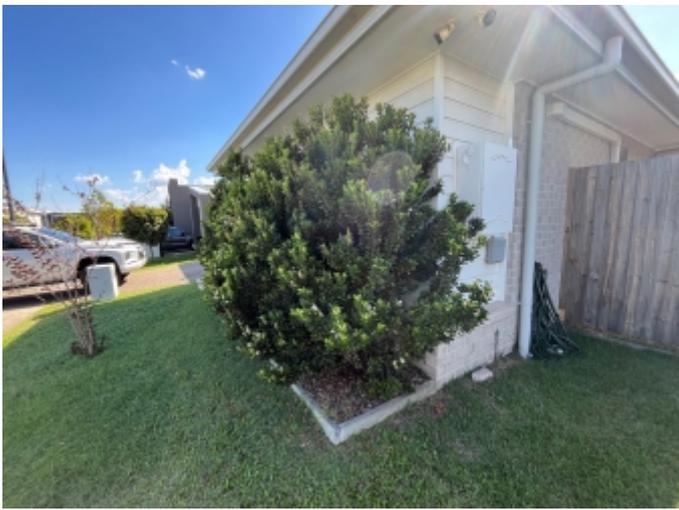
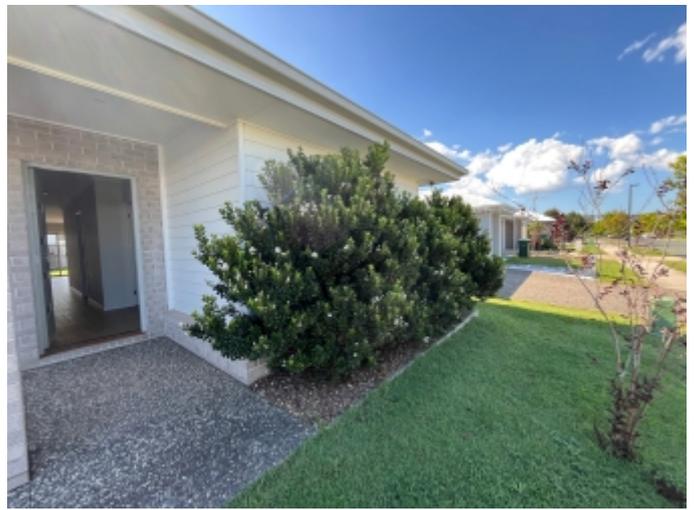
Garden beds and vegetation against external walls. Recommend removing

Showing example of the garden beds and vegetation
