16 Henry Street, Nirimba QLD, Australia

Pre-Purchase Standard Property & Timber Pest Report

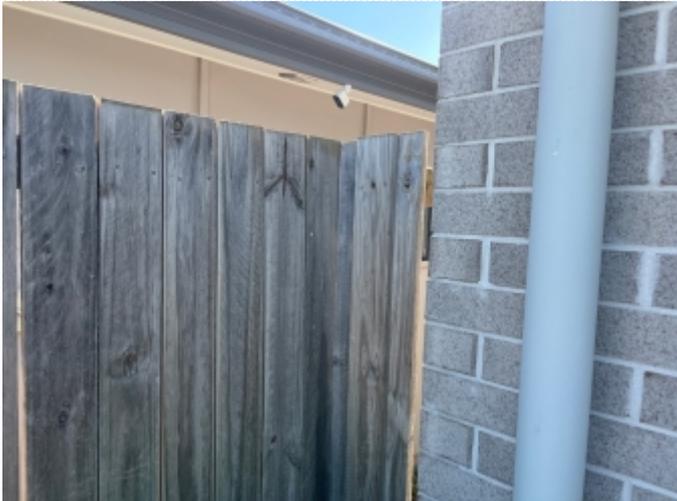
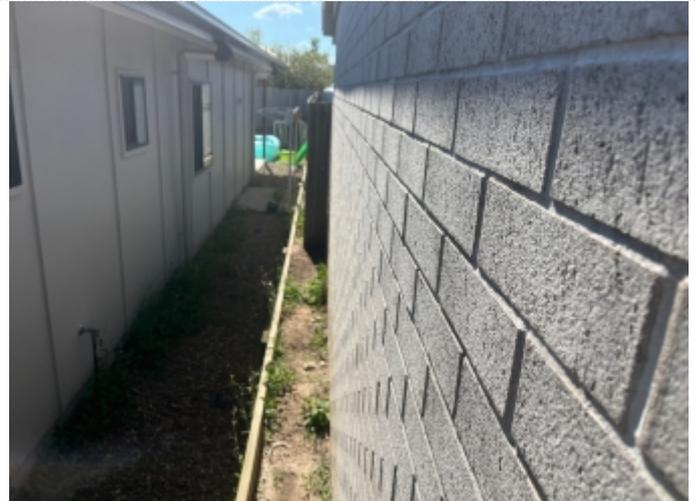
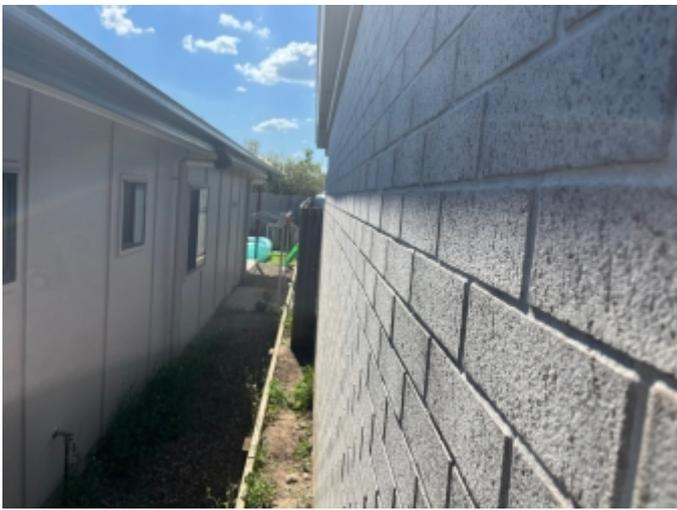
Photo Comments: Showing example of the external walls

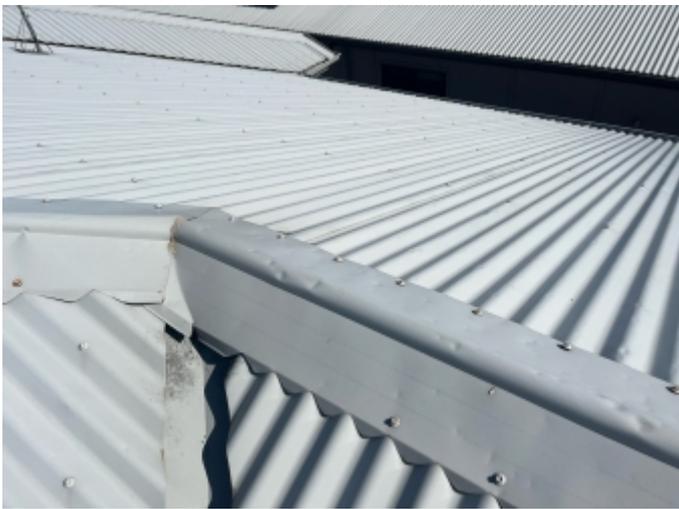
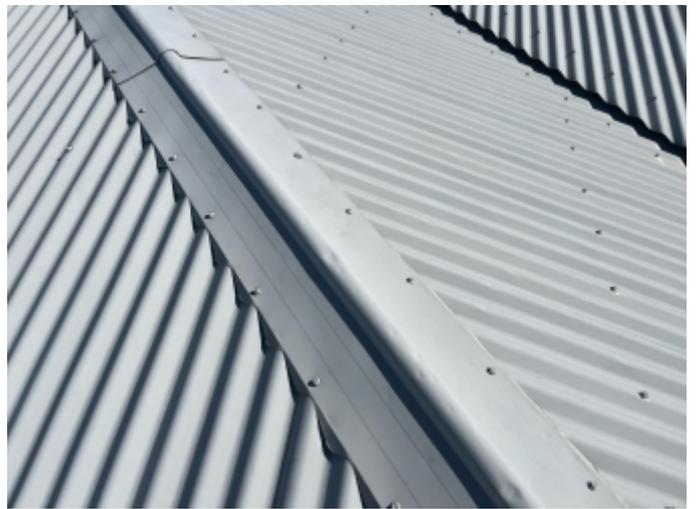
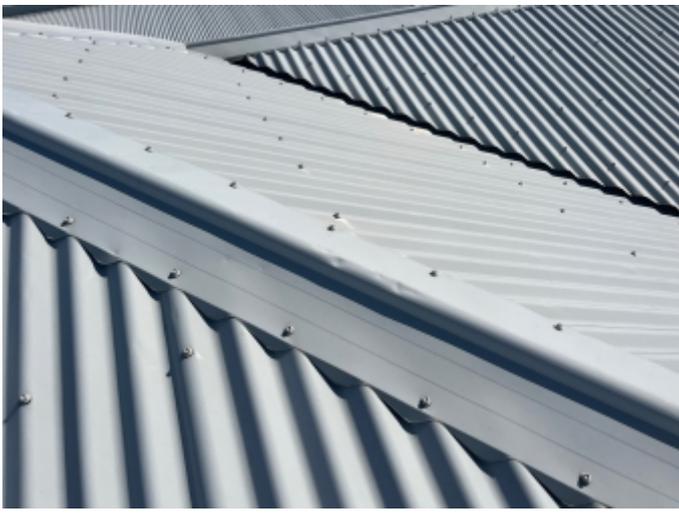
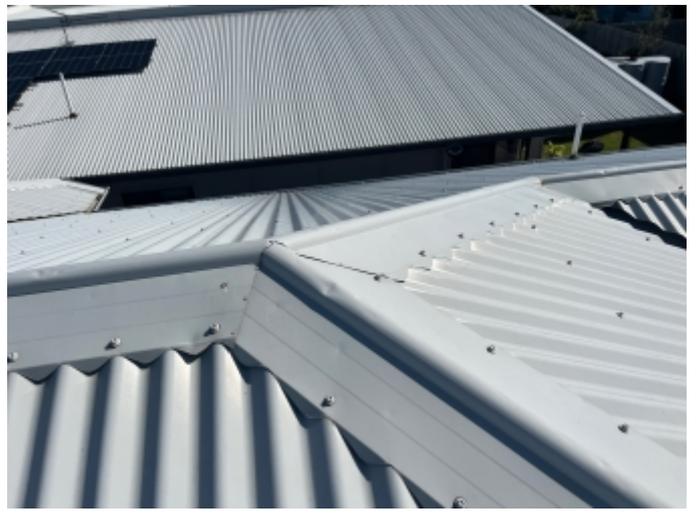
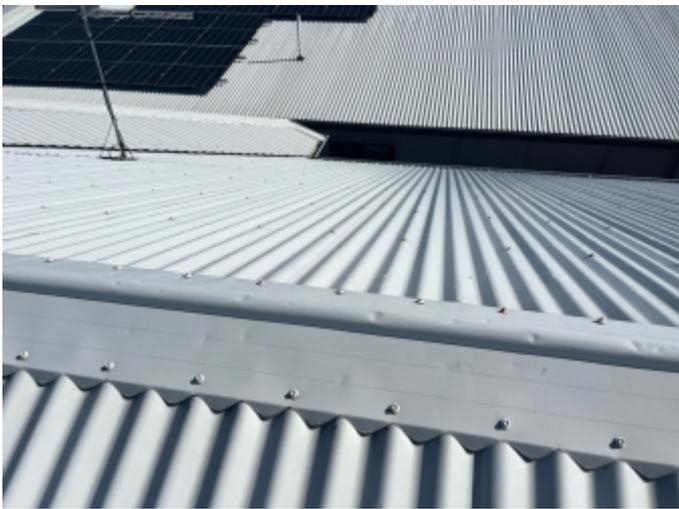
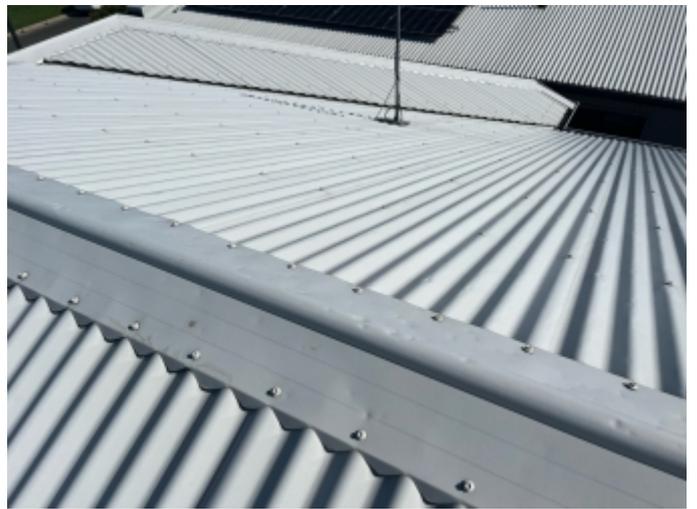
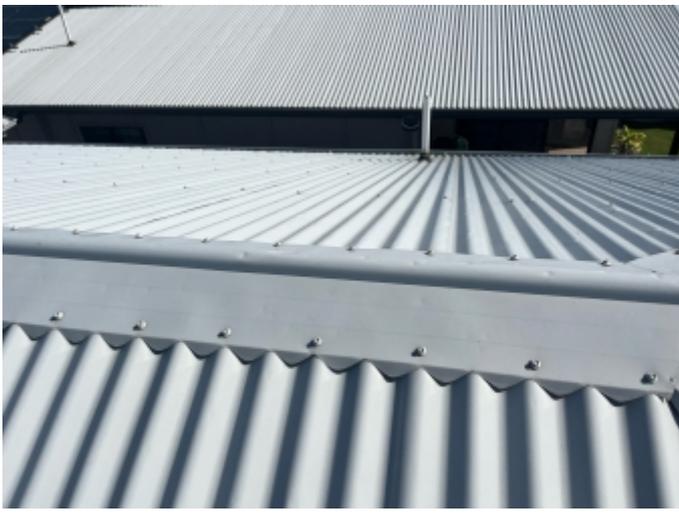
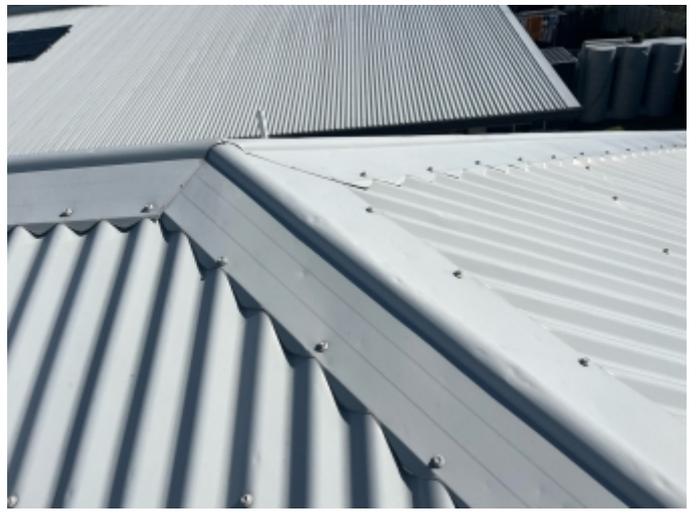
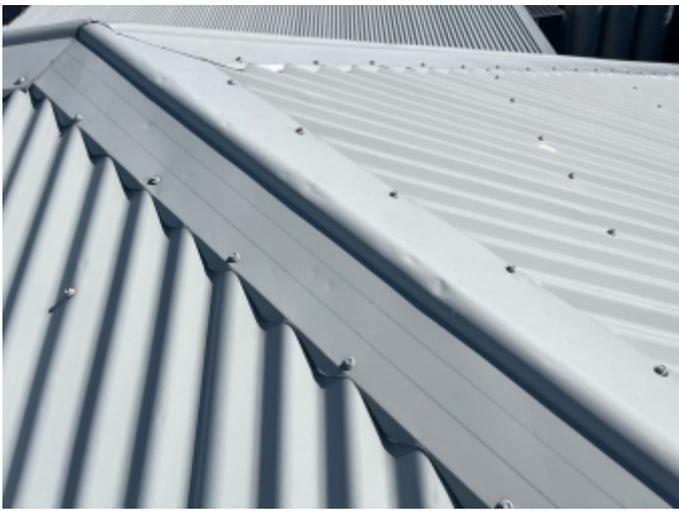
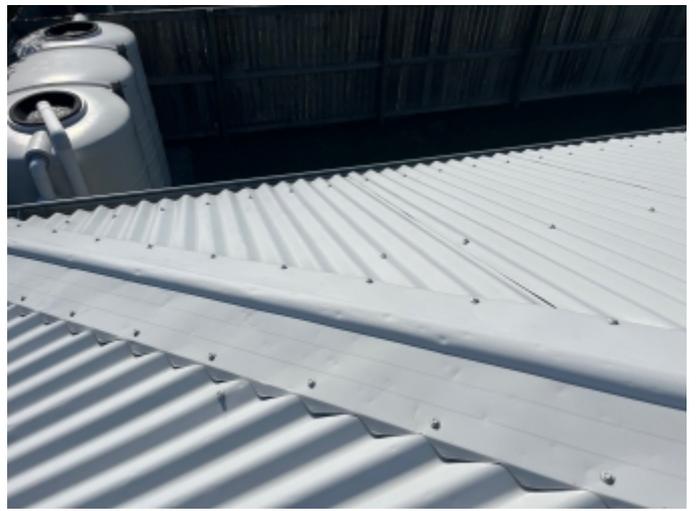
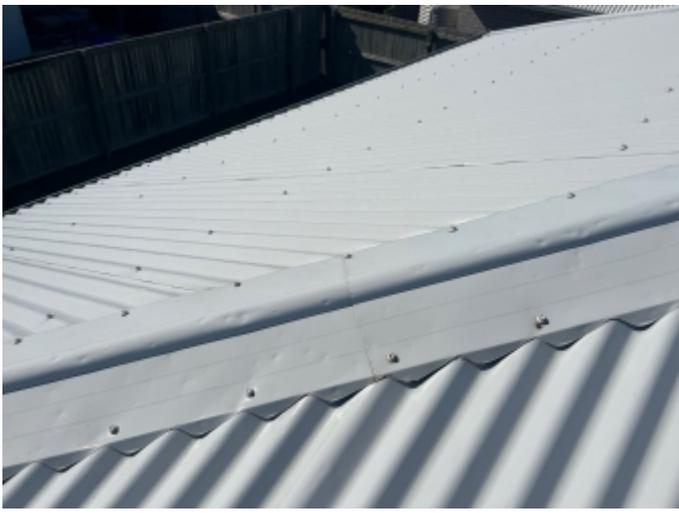
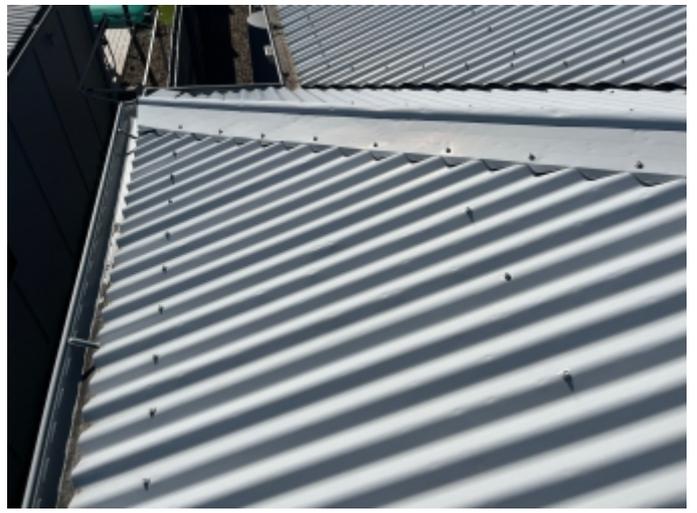
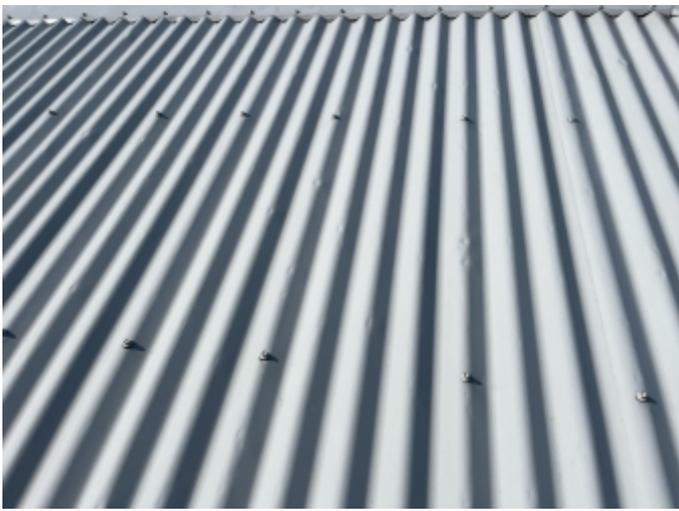
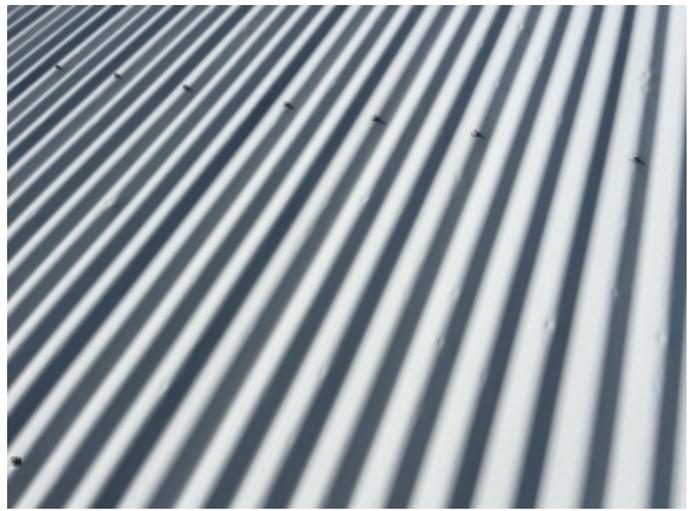
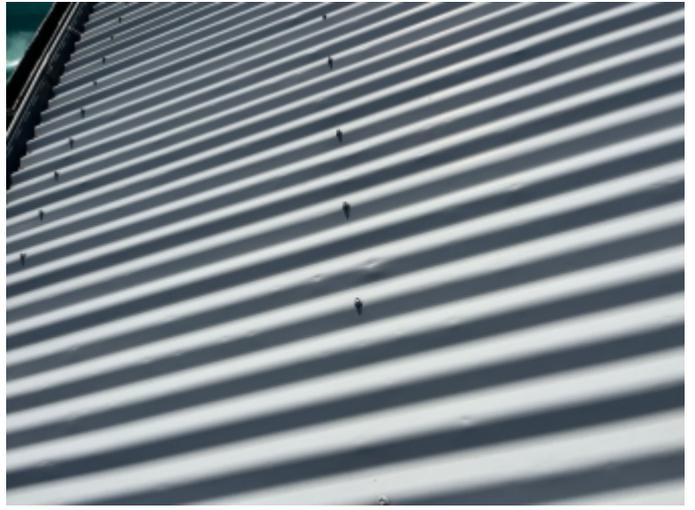
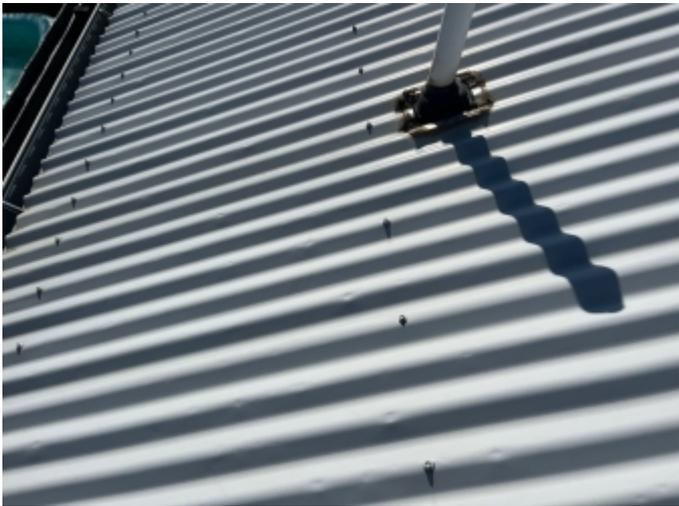
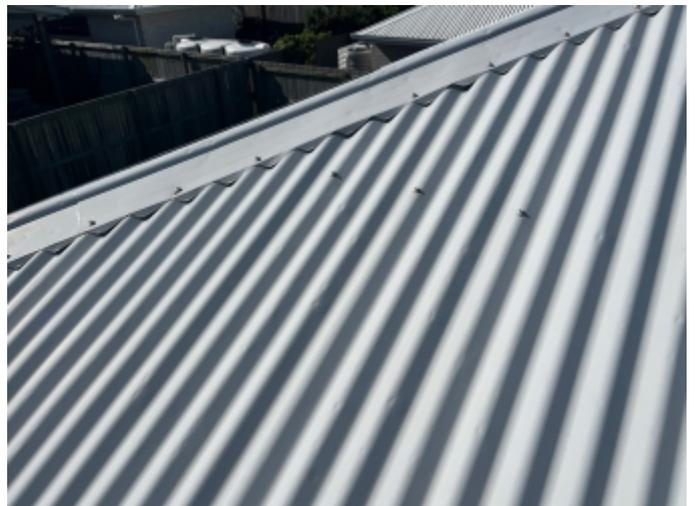
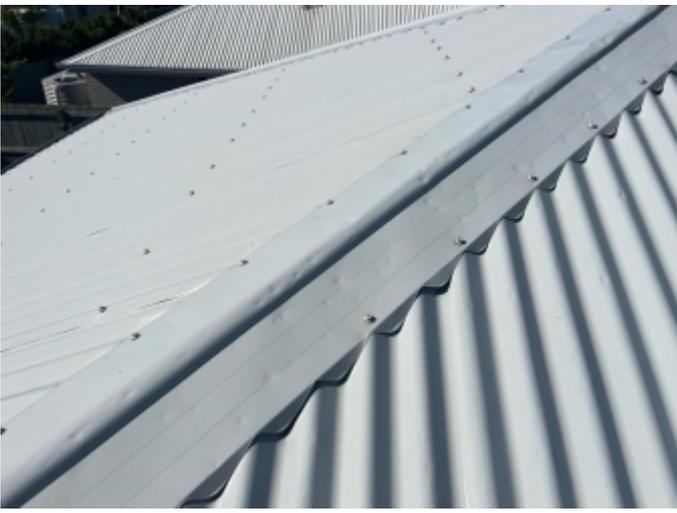
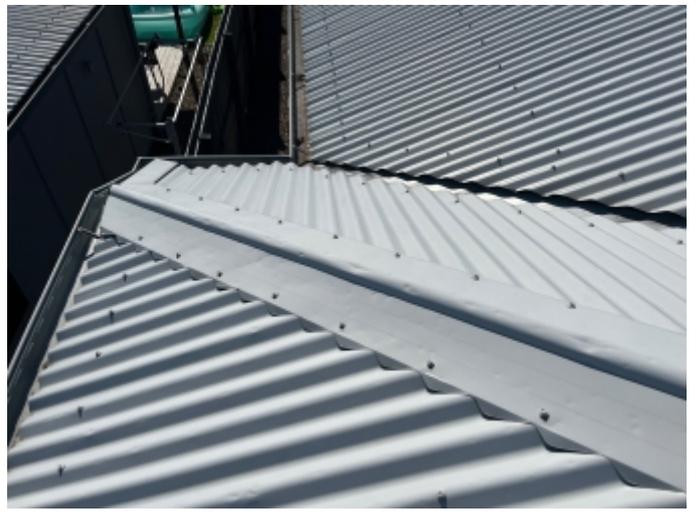
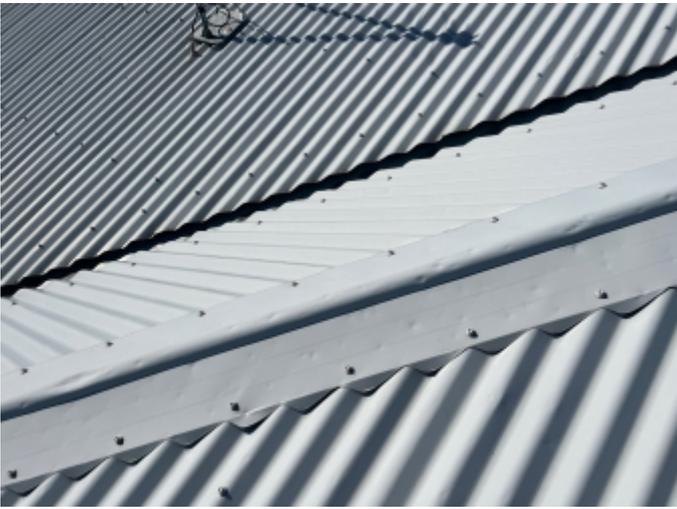
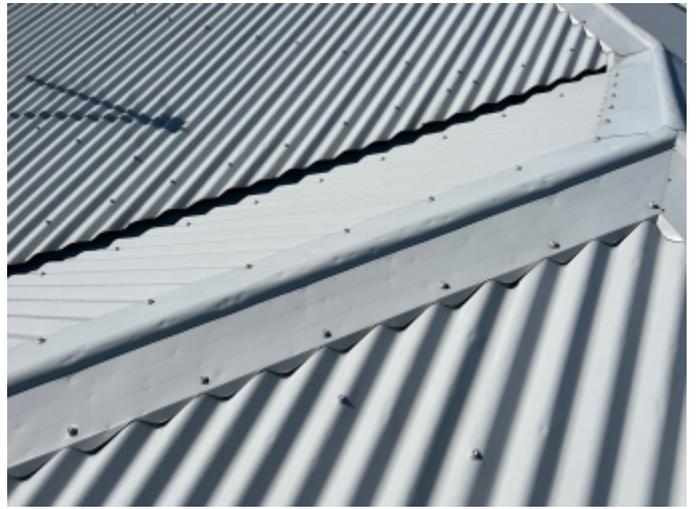
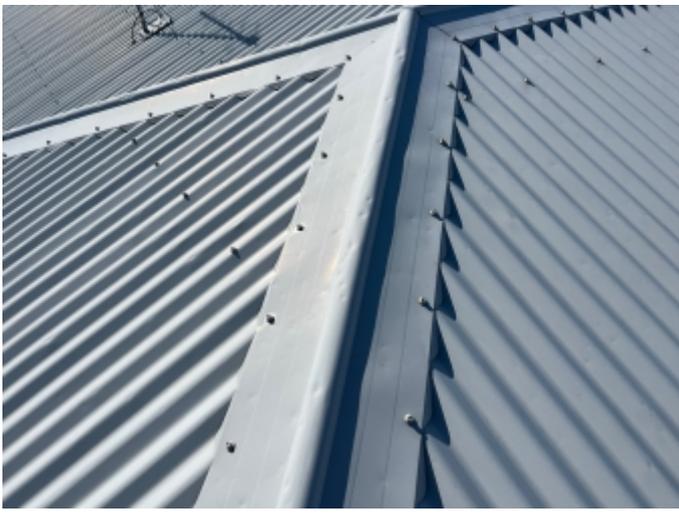
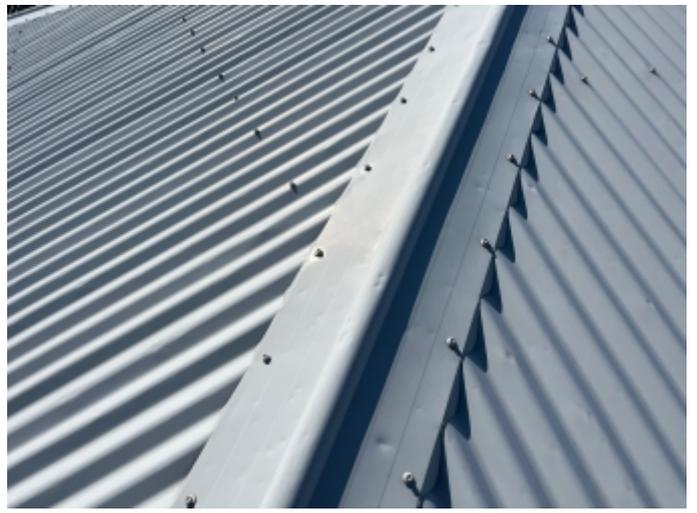
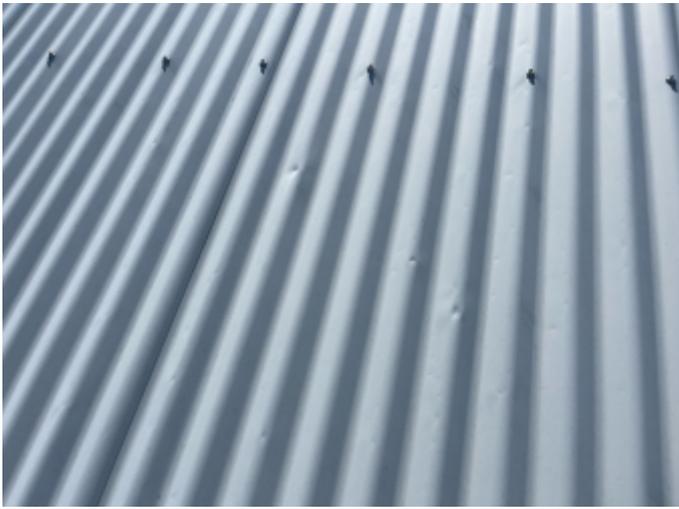
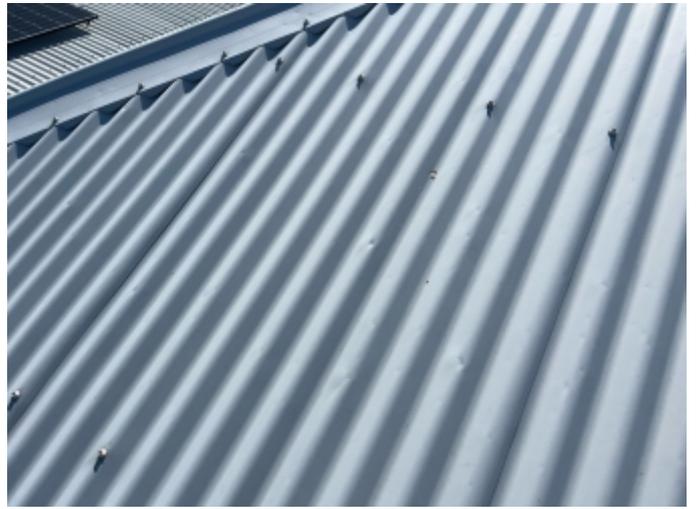
Details of Major Defect	Significant denting to throughout roof. Appears hail damage. Consult hail specialist regarding assessment and check with owner regarding if any previous hail claims made.
Photo(s) of Defect

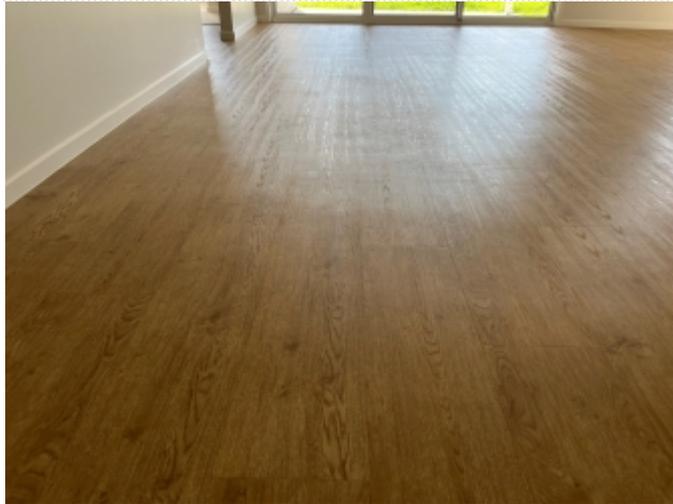
Undulating floors to parts of the building. Recommend a builder to rectify to reduce the risk of further deterioration.

Slightly uneven sections. Appears non significant.

Showing example of the undulating floors

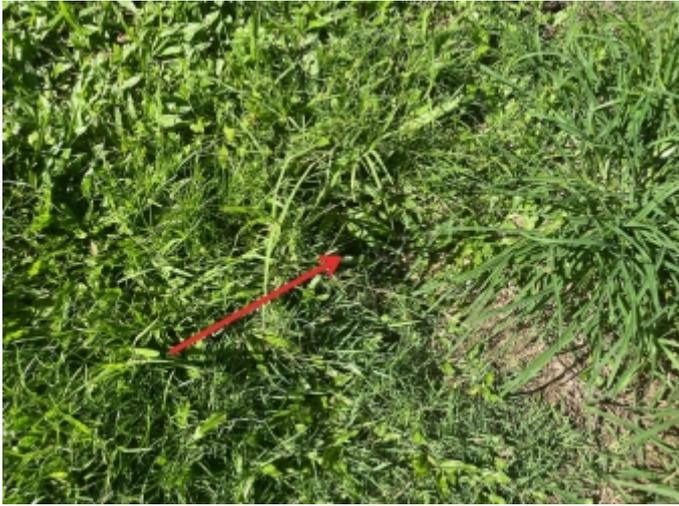
Poor surface drainage to some areas. Recommend a plumber/landscaper to rectify to prevent water ponding around the building to reduce the risk of footing movement and other moisture related issues.

Showing example of the poor surface drainage

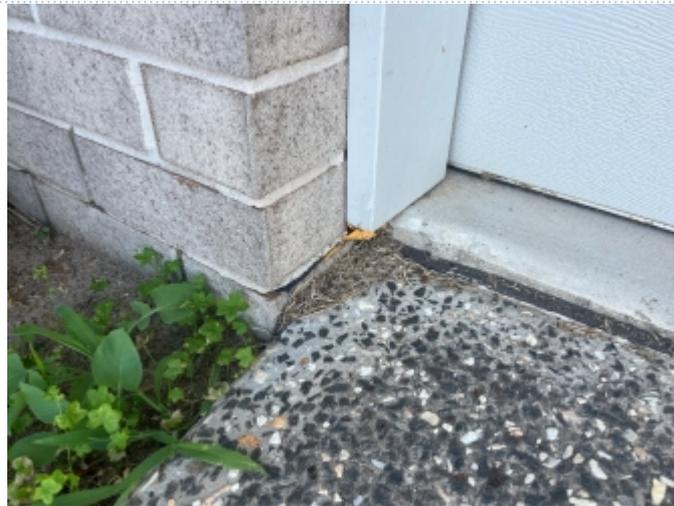
Showing example of the chemically treated membrane

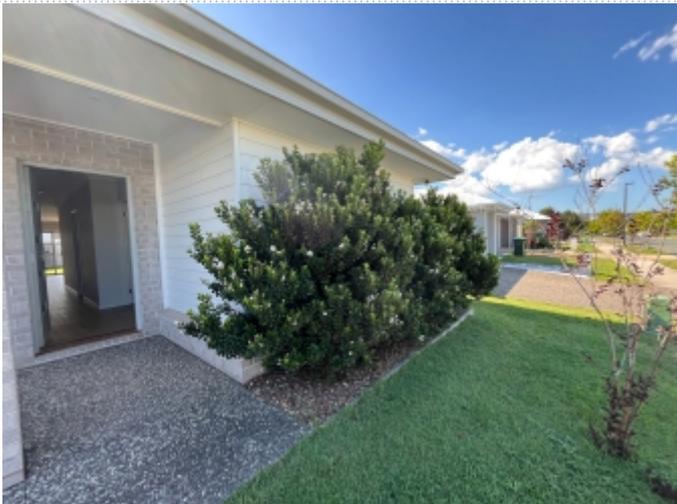
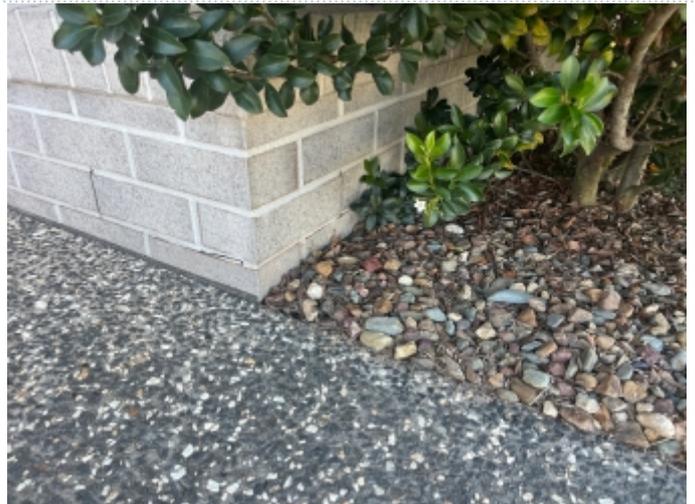
Showing example of the obstructed termite management system

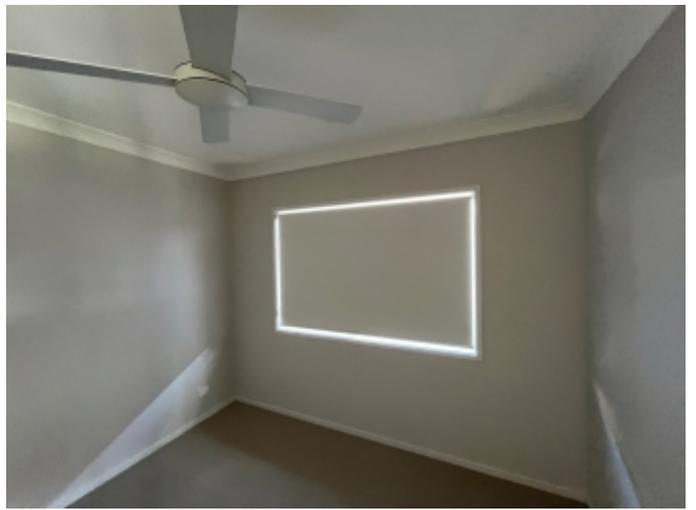
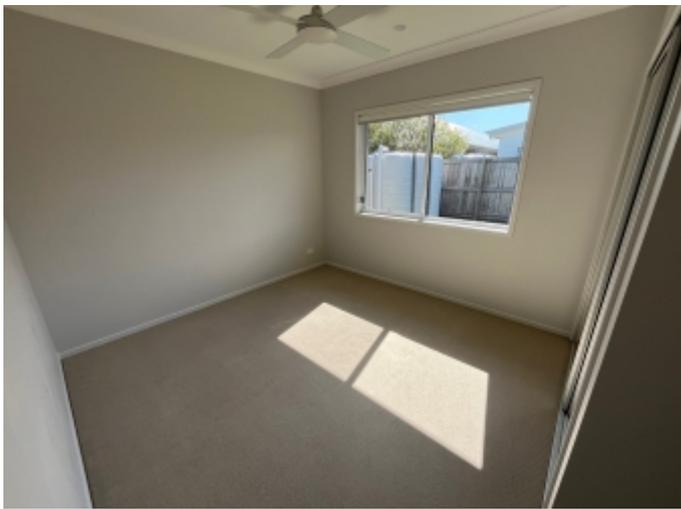
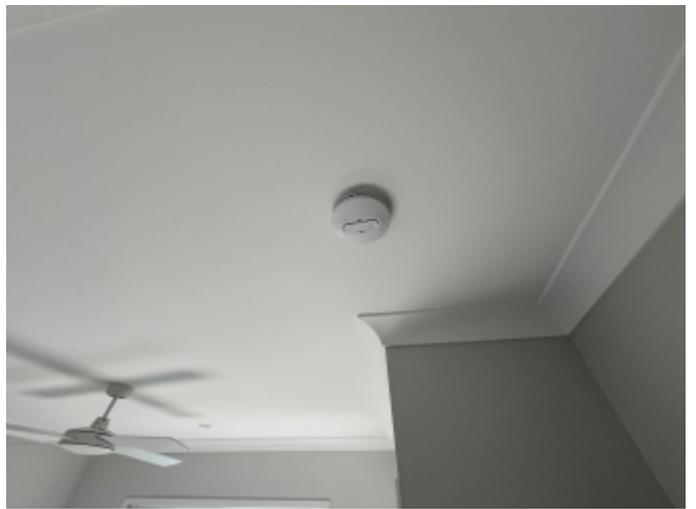
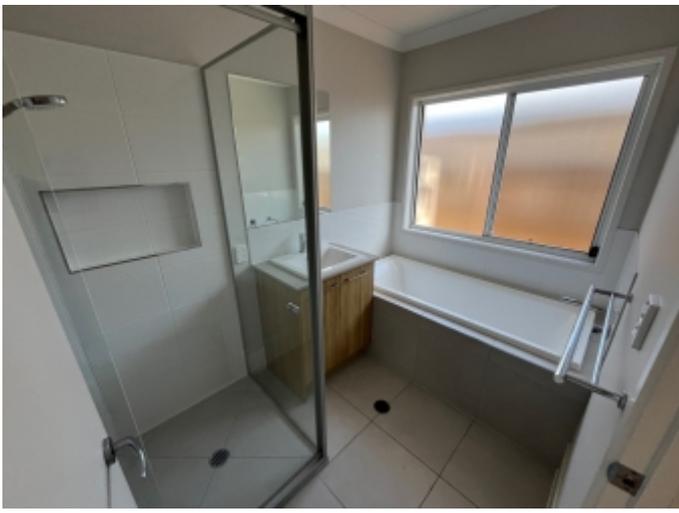
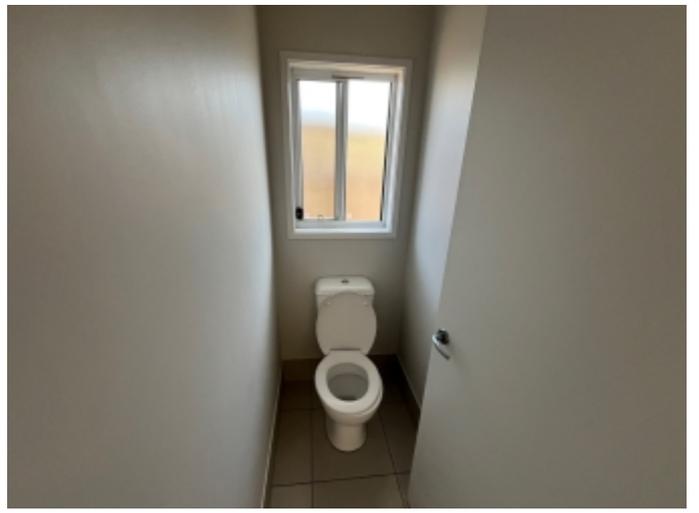
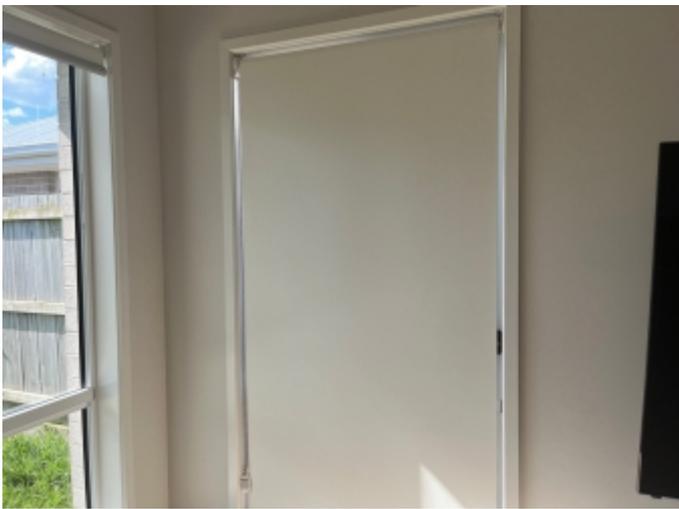
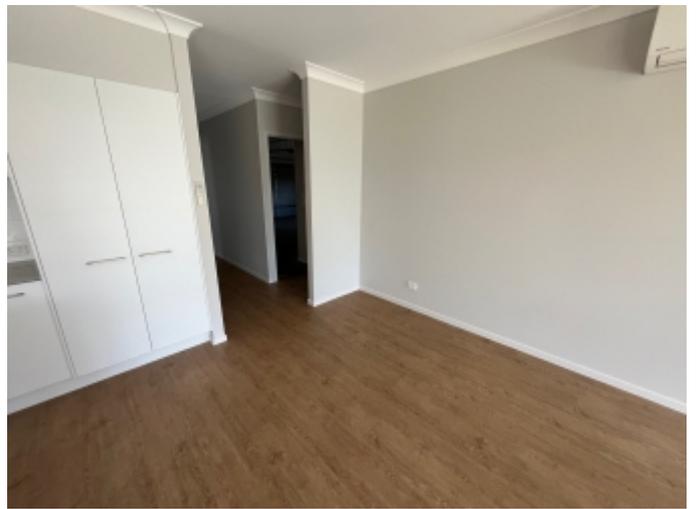
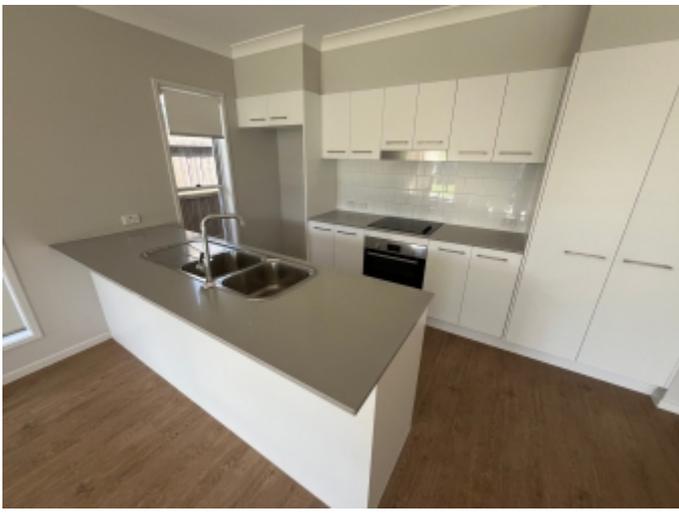
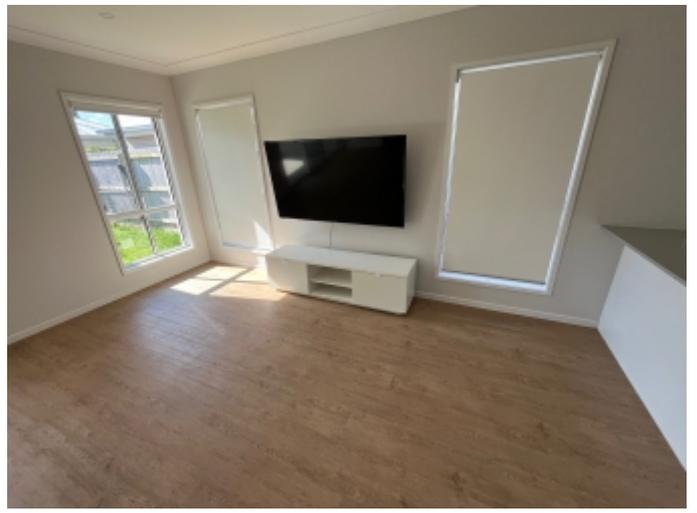
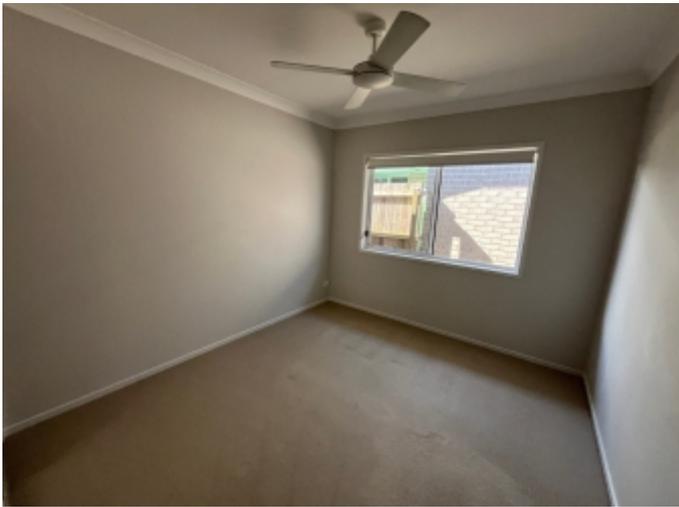
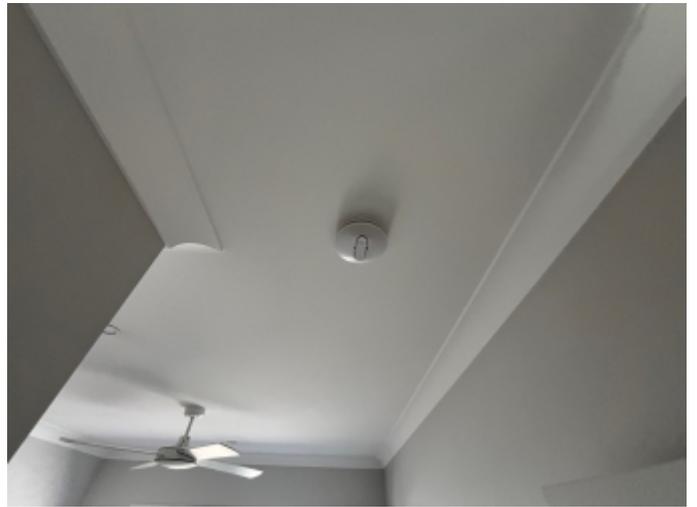
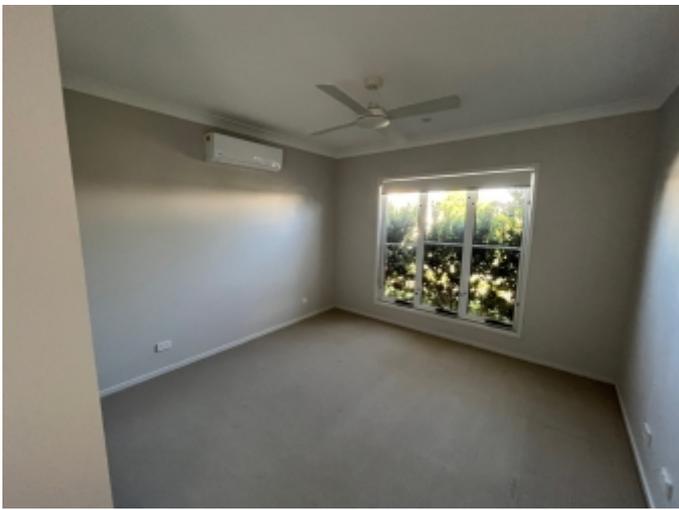
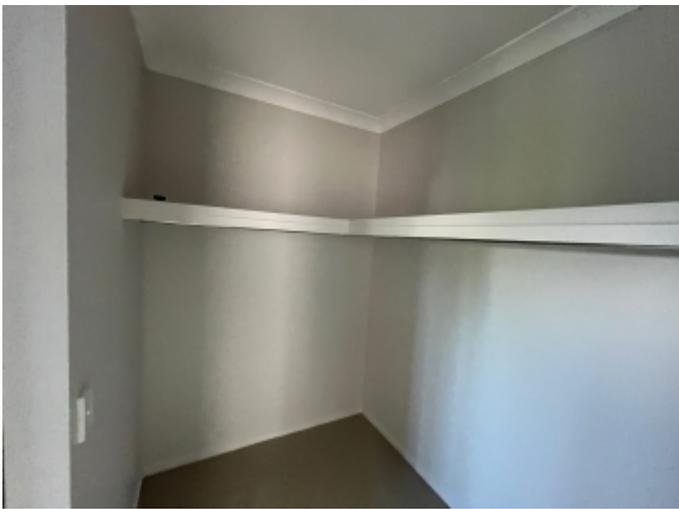
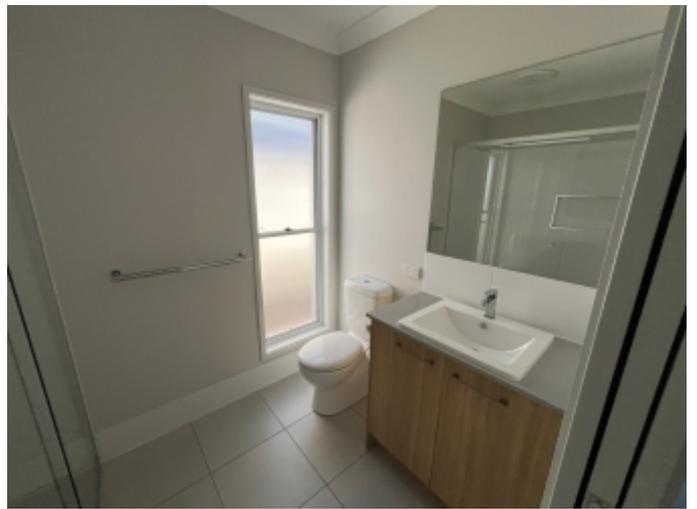
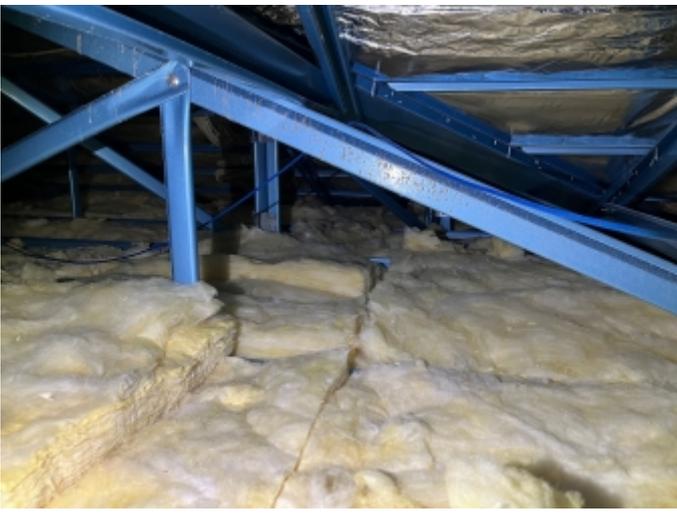
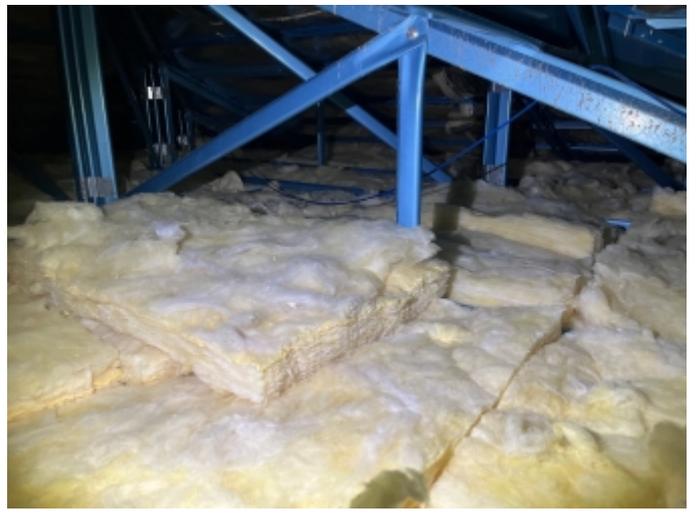
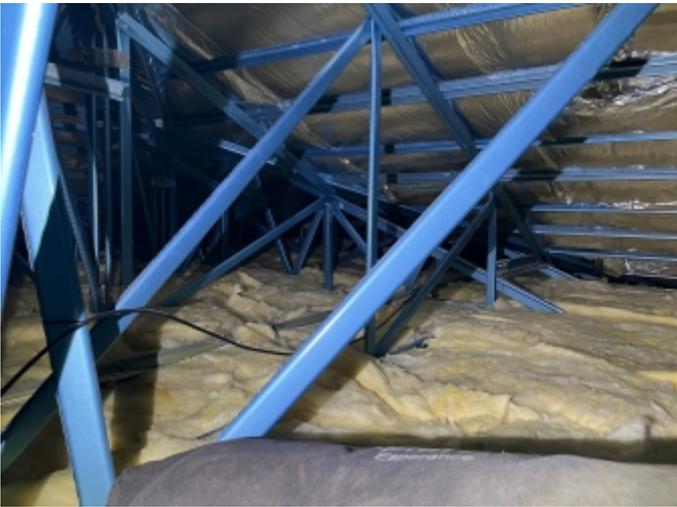
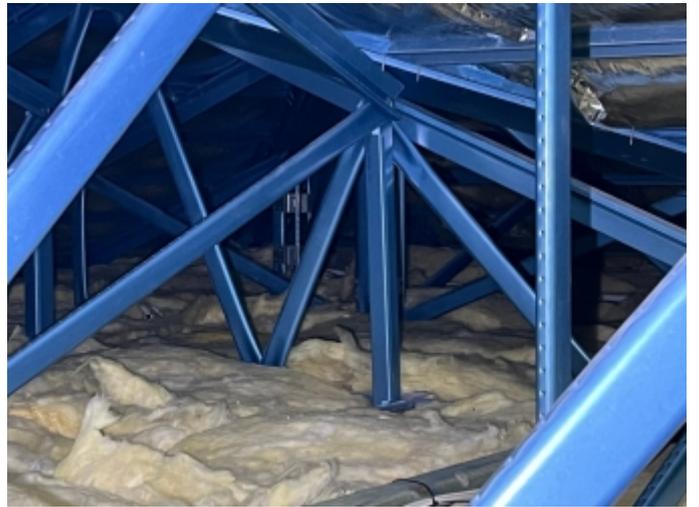
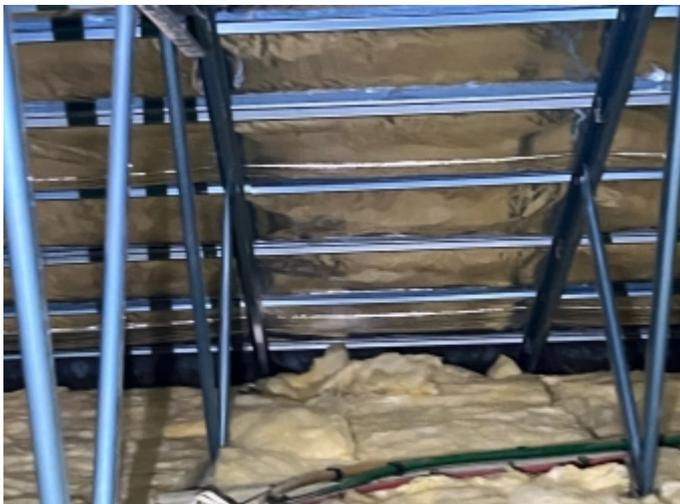
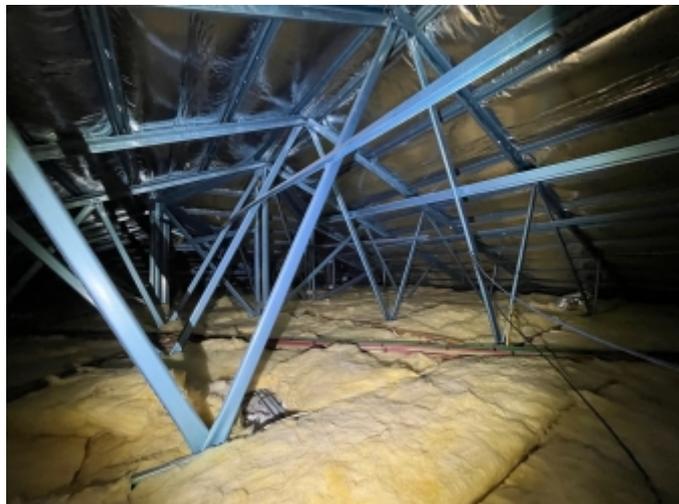
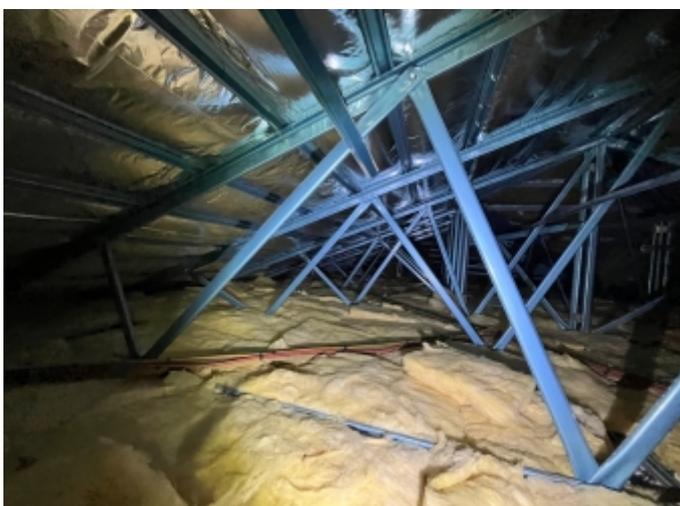
Photo Comments

Showing example of the property at the time of the inspection
